Manhole Inspection Summary

Manhole # S25WW1015MH

Insp Date: **1/15/07 11:19 AM**

Location Address: **730 DEEPPDENE RD**

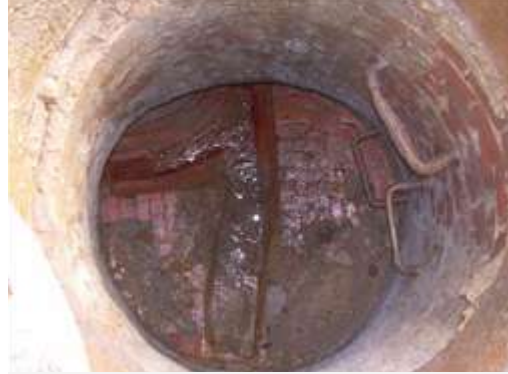
Top View

Evidence of surcharge - Bench debris. Channel debris. Corroded steps.

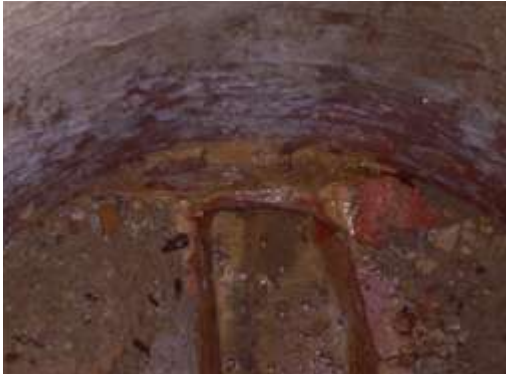
Defect

Barrel infiltration.

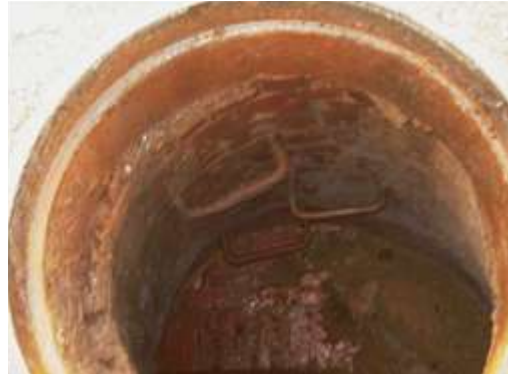
Defect

Frame leaks. Frame offset. Corroded steps. Adjustment deterioration and infiltration.

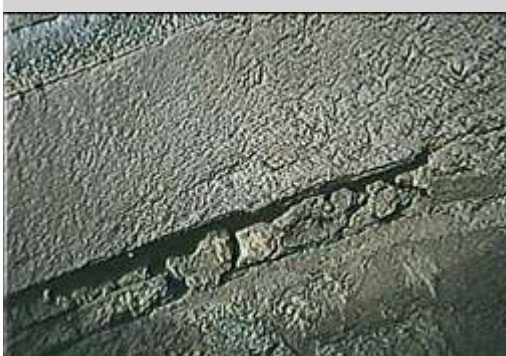
Defect

Frame leaks. Adjustment deterioration and infiltration.

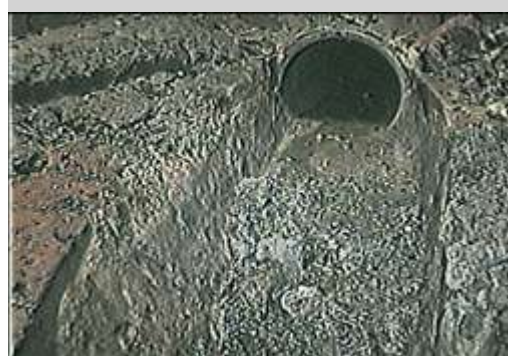
Defect

Channel debris.

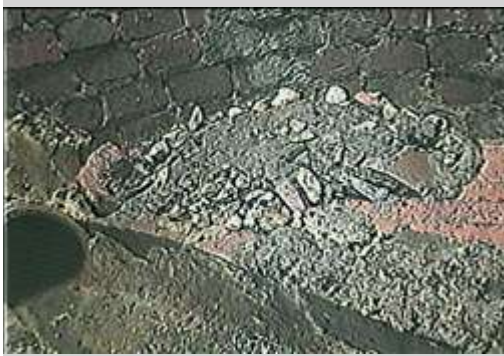
Defect

Barrel deterioration and infiltration. Bench debris.

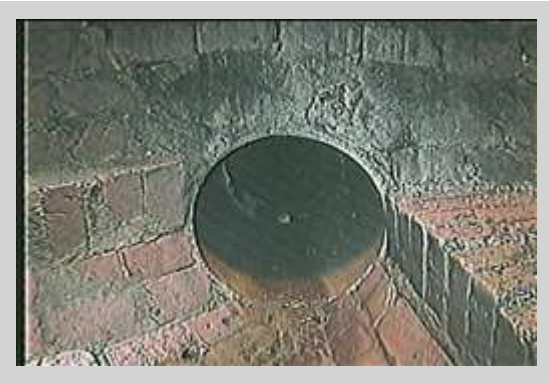
10 in. Circular Gravity Sewer Pipe Out @ 12 O'Clock

Barrel deterioration and infiltration. Channel deterioration.

Infiltration: **Evidence** Pipe Seal Cond: **Cracked**

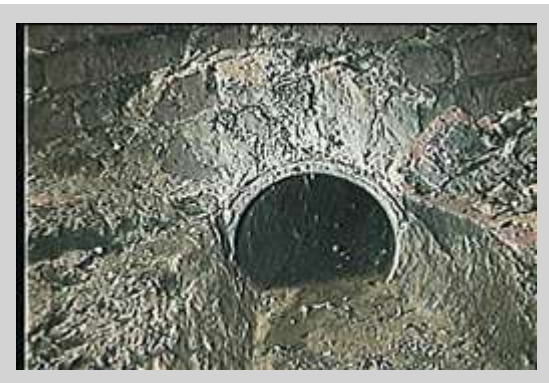
8 in. Circular Gravity Sewer Pipe In @ 7 O'Clock

Deposits: ☐ None ☒ **Mud** ☐ Sludge ☐ Debris ☐ Grease

Silt Depth: **1** (in.) Deposits Extent: **Light**

Infiltration: **Evidence** Pipe Seal Cond: **Cracked**

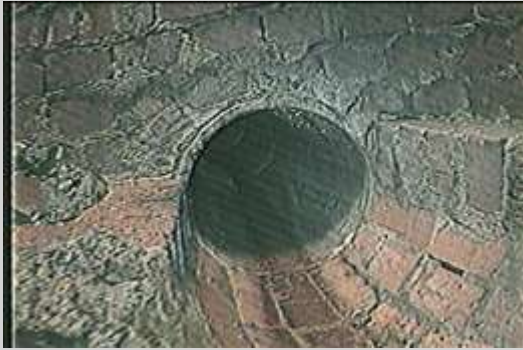
Pipe In @ 9 O'Clock

Infiltration: **Evidence** Pipe Seal Cond: **Cracked**
